**RE: Progress report for January 2009 activities - Hecla Mining Company Apex Site
(EPA ID No. UT982589848, Docket No. RCRA-8-99-06)**

SUBJECT: Progress Report No. 57 for period ending January 31, 2009; Pond 2 Final Closure - Apex Site, Washington County, Utah

TO: Paul Glader (Hecla Mining Company)
FROM: Doug Gibbs (Monster Engineering Inc.)
DATE: 2/9/09
SUBJECT: **Surface Monument Survey Data Review – Apex Site**

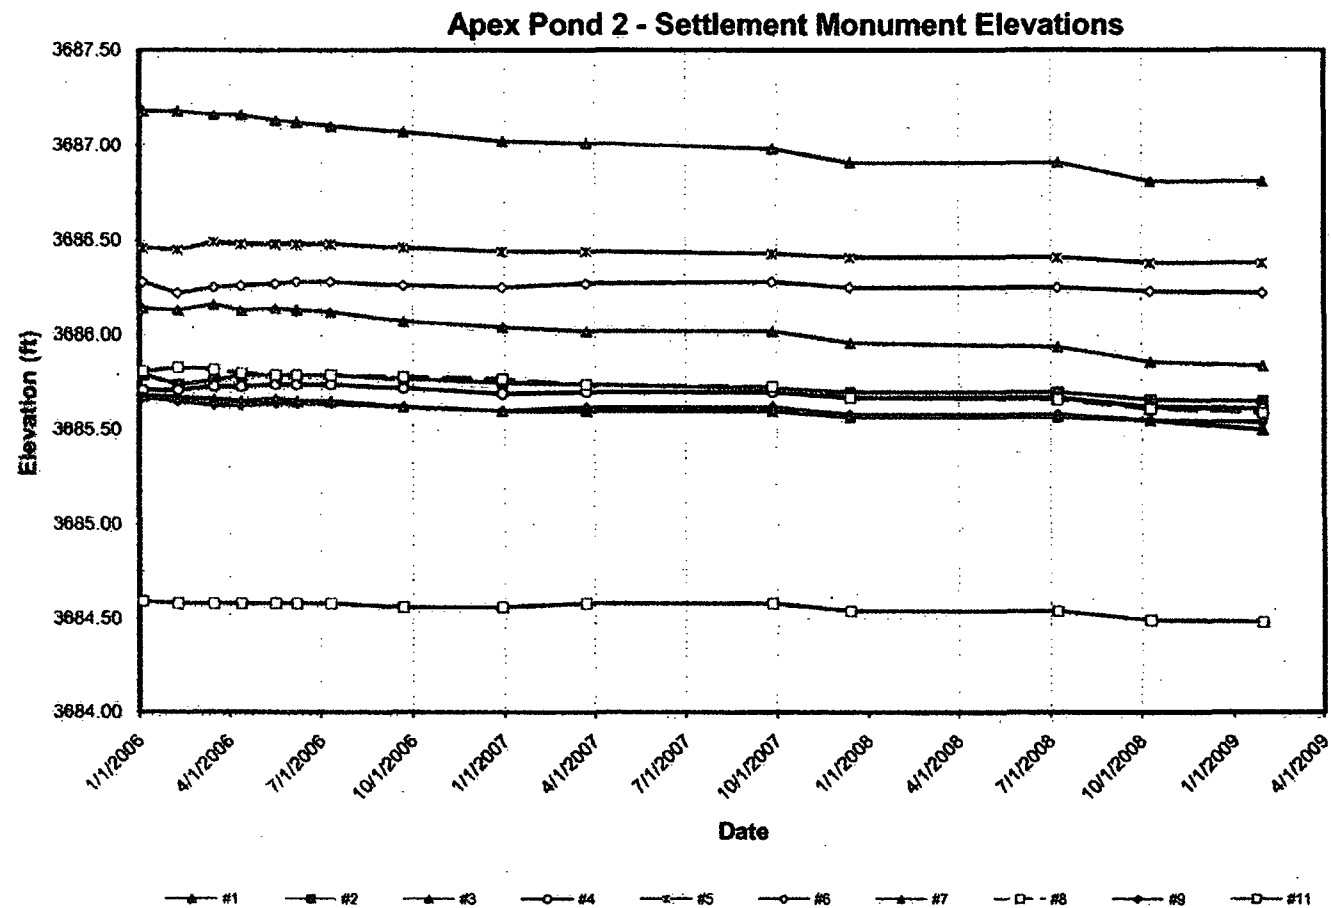
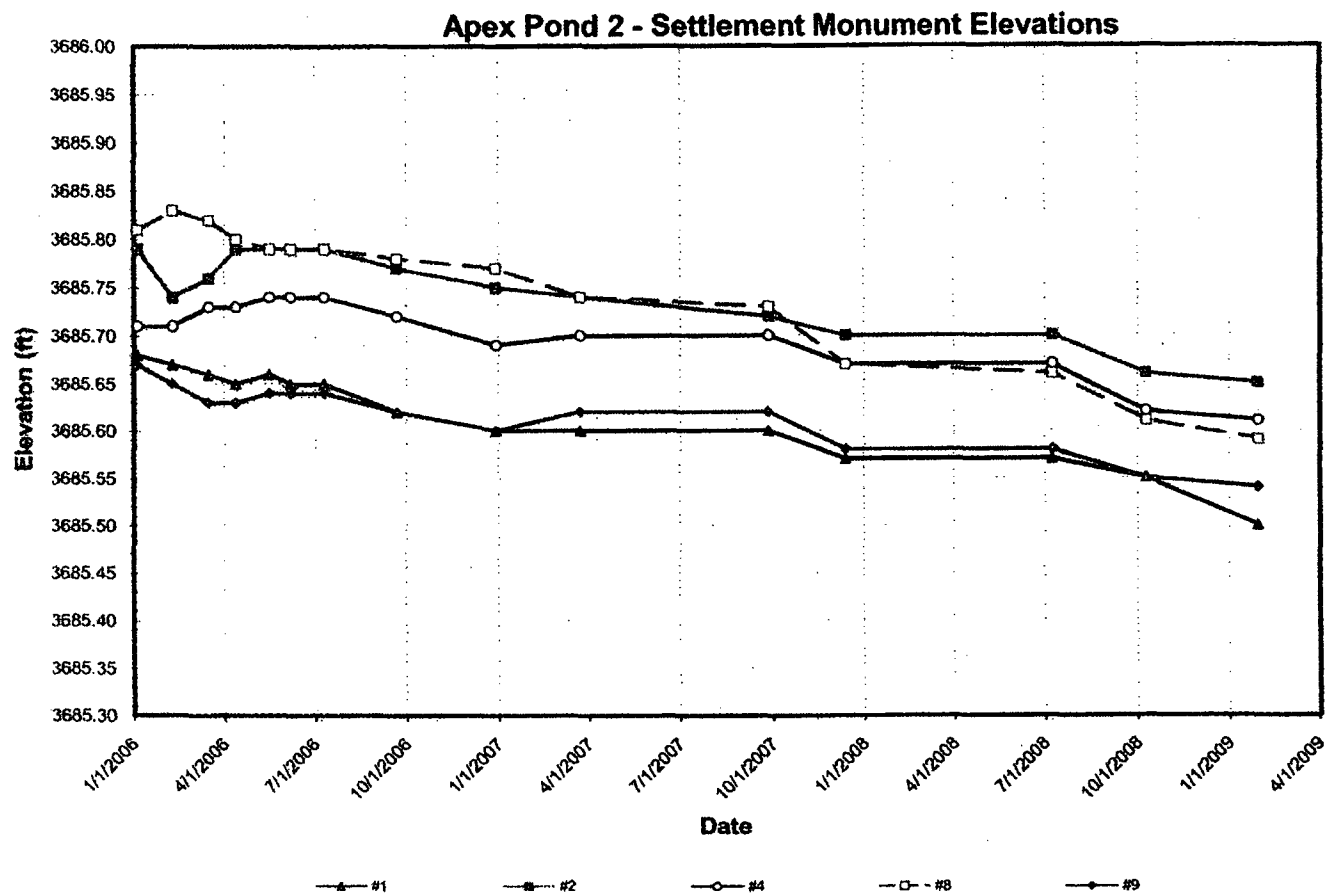
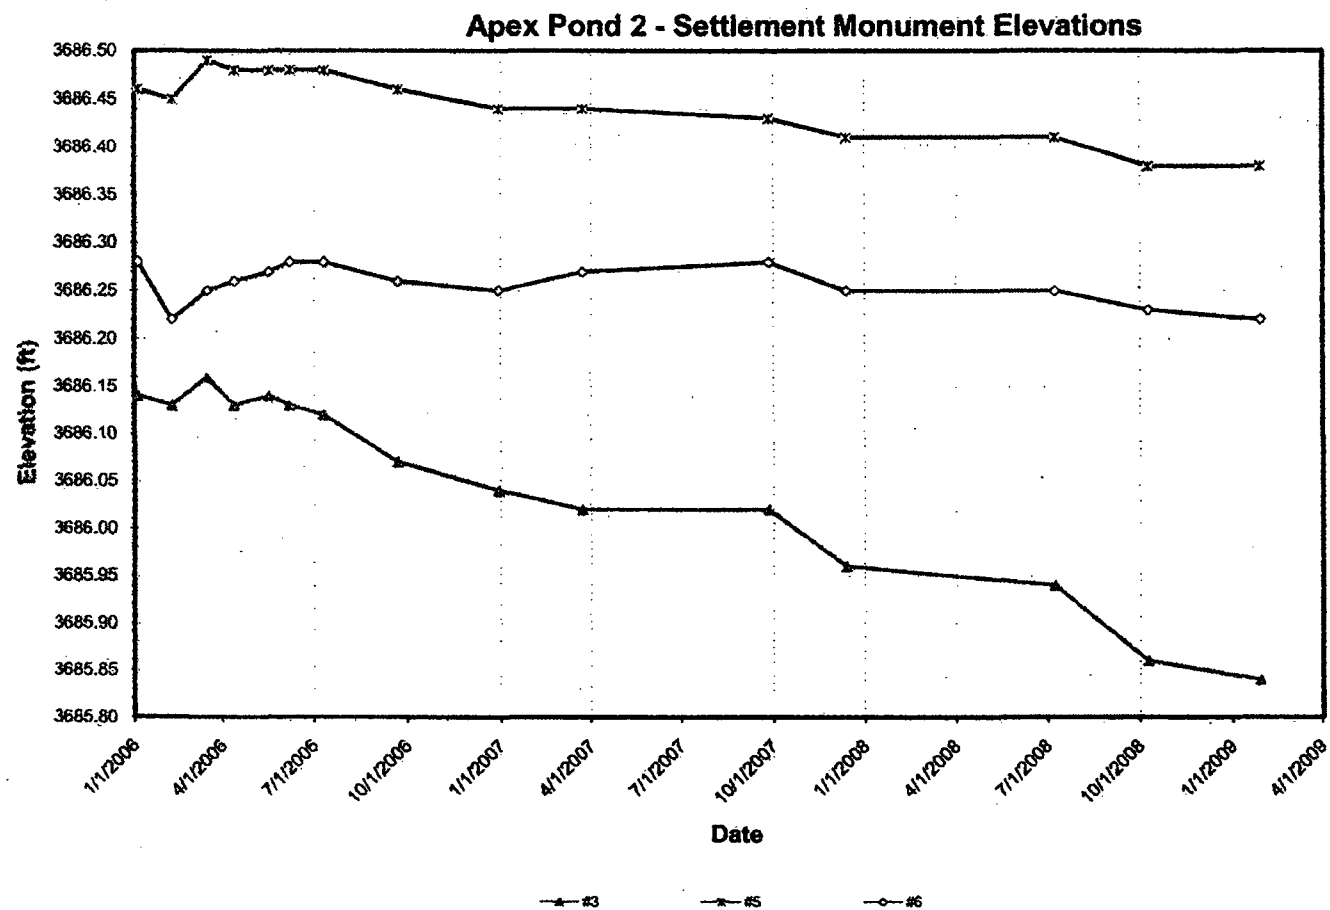
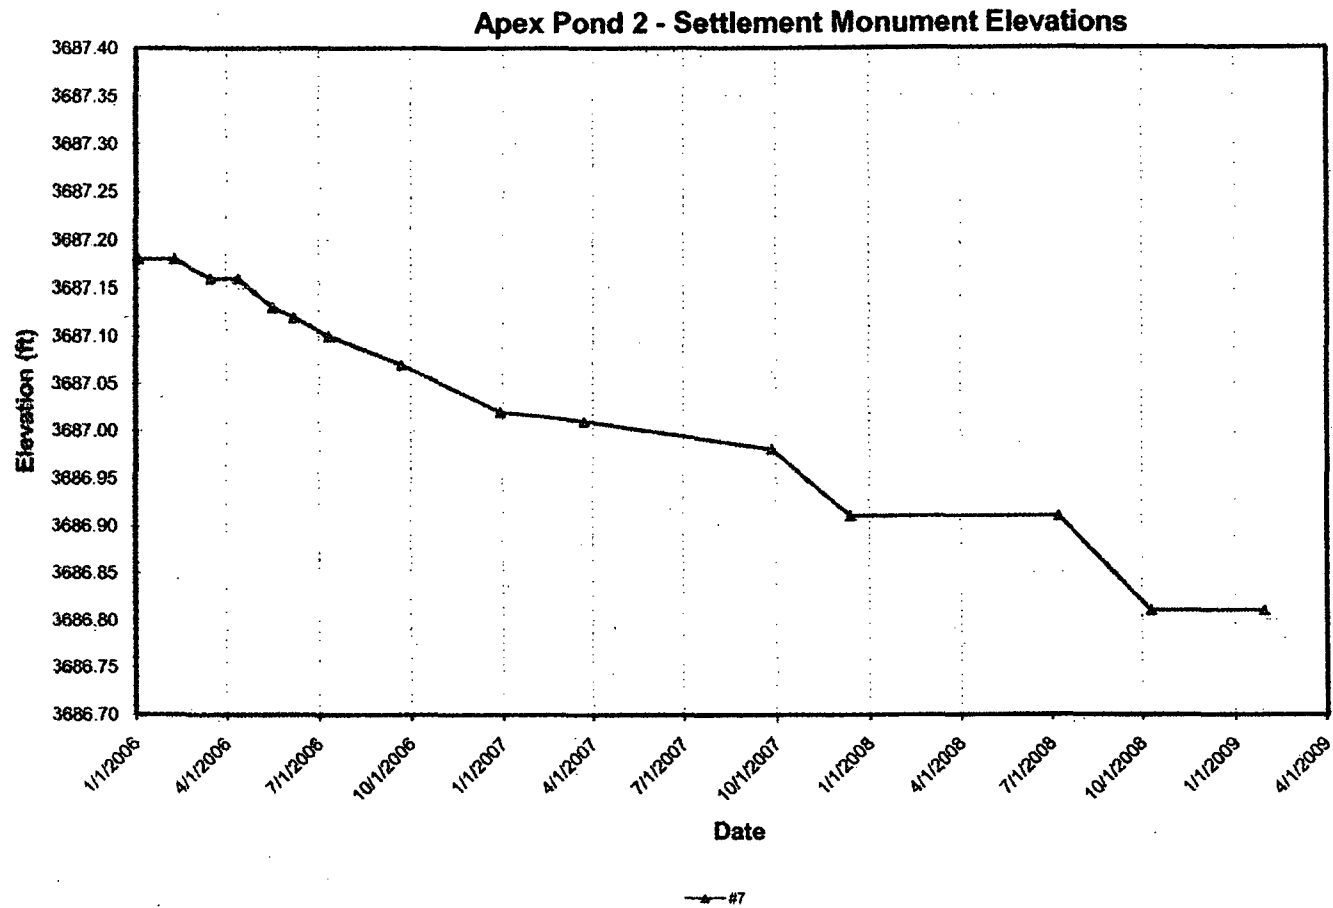
maintain a zero elevation change at Monument #10, then a general trend of decreasing elevations becomes apparent. All elevation data provided by Alpha Engineering is presented graphically on the following pages. The first graph shows all monuments (except monitor #10 the baseline point) on a scale that allows all data to be compared. The next five graphs have expanded and equivalent "Y" axes scales in order to more clearly show elevation changes, and for ease of comparison between graphs.

Survey data shows that the northern half of the impoundment has settled slightly more (between 0.14 and 0.3 feet) than the southern half (0.06 to 0.13 feet). A plan view of the impoundment showing each monument location (provided by Alpha Engineering) is attached on the last page of this document. Included on this map are contours showing approximate total settlement of the top surface since monument installation. The largest measured settlement is, as expected, near the center of the impoundment (monitor #7) at -0.37 feet. Slightly greater settlement in and nearer the center of the impoundment is to be expected as significant quantities of fill were placed in this area during construction. Additionally, greater settlement should be expected on the northern half of the impoundment based on the locations and methods utilized to place the original cover materials (prior to final reclamation activities). One portion of the initial reclamation project consisted of placing a temporary earthen/rock cover over the impoundment waste materials. According to Chris Gypton and Alan Wilson, these cover materials were initially dumped into the impoundment in the southwest corner and then were pushed across the impoundment towards the northeast corner. This placement method created a mud wave of unconsolidated waste which moved towards the northeast corner, and eventually a thicker deposit of unconsolidated waste materials in the northern half of the impoundment.

There appear to be no concerns to date with settlement. There are no low spots and no signs of ponding of rain water. As expected with long-term consolidation, the data shows that settlement rates are slightly decreasing over time. Consolidation of both the underlying waste materials and final reclamation cover materials appears to be very minimal. This very minor amount of consolidation also reflects that it is unlikely any liquids are leaving the impoundment.

Based on the data showing that the facility has experienced consistently low settlement rates over the past three years, MEI recommends that Hecla continue to monitor the facility, however survey data need only be collected on an annual basis. Please call or email me if you have any questions concerning this review.
